Intel[®] Celeron[®] Processor Specification Update

Release Date: April 02

Document Number: 243748-044

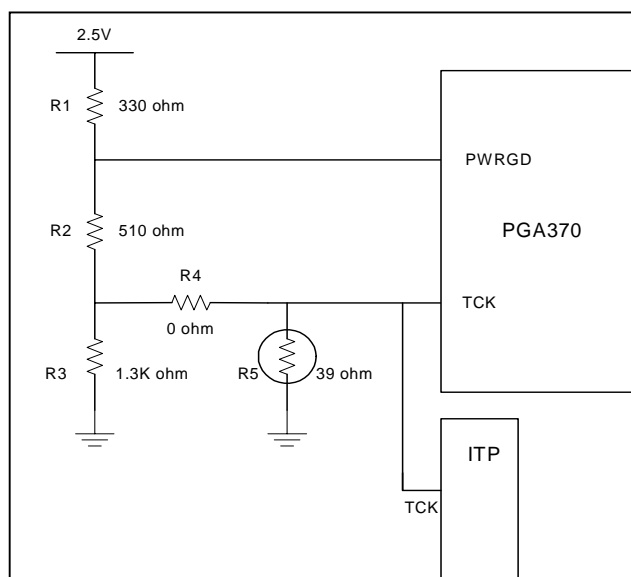
Figure 1 Celeron® on 0.13 Micron Processor 256K Platforms Workaround

In addition, the example workaround circuits shown do not support production motherboard test methodologies that require the use of the processor JTAG/TAP port. Alternative workaround solutions must be found if such test capability is required.

For Production Boards:
Depopulate R5

To use ITP:
Install R5, Depopulate R4
